# **CONDITIONS' MONITORING FOR SUCCESSFUL MAINTENANCE STRATEGY AT INEOS PLANT IN ROSIGNANO**

### **Oil analysis results**

### **Overhaul**

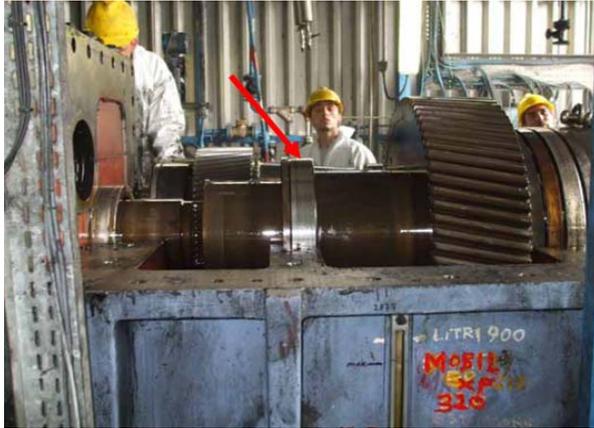
After several levels of dismantling shields, components and gears/bearings, as well detailed in the pictures taken (image 1 through 4), there was the evidence of several major signs of wear related with pitting, fretting and in site spinning of few roller bearings.

*Fig. 3 - Crankcase after removal of top cover;*

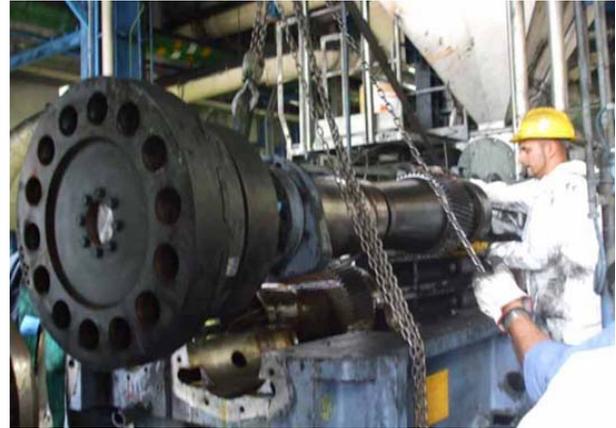
*Fig. 4 - High speed shaft removal;*

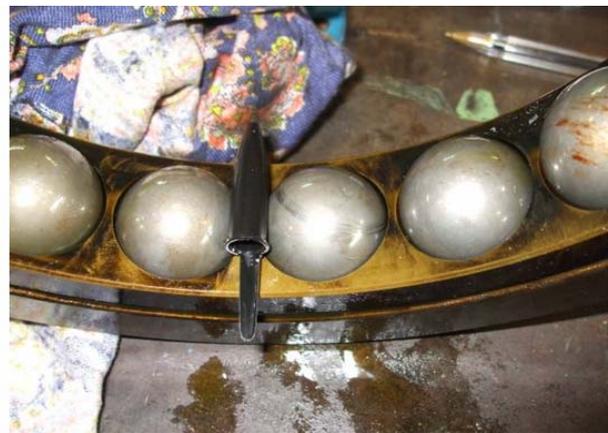
*Fig. 5 - 151 Bearing with circular wear signs;*

The work with final tests came to conclusion by May 23<sup>rd</sup>, and since that moment, the machine is running fine.
